# Eagle Home Inspections

Your Name Here  
Main Street America  
Your Town, NJ

Date of Inspection: 11/22/2014

# Property Analysis Report

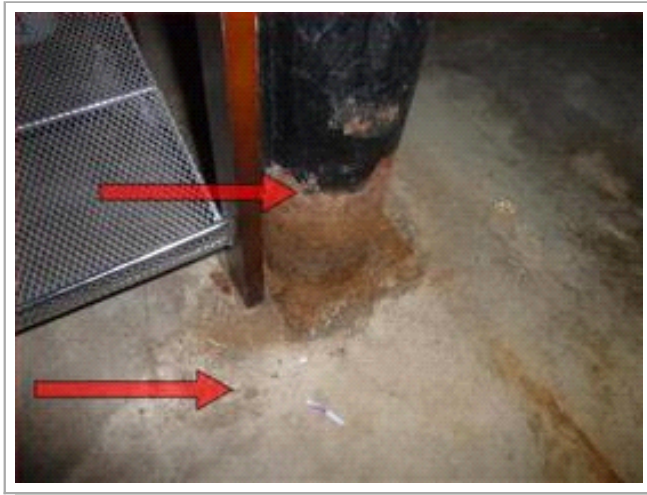
Figure Number 1

The basement has evidence of dampness, water stains and signs of possible water seepage/entry. Recommend: Qualified Remodeling Contractor Repair/Correct as needed.

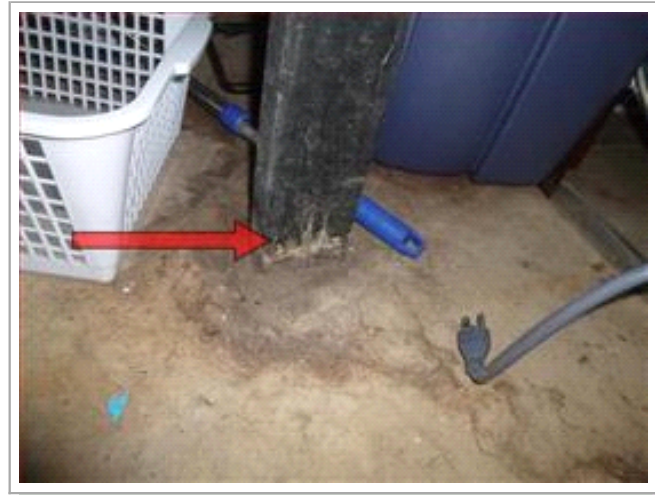
Figure Number 2

The basement has evidence of dampness, water stains and signs of possible water seepage/entry. Recommend: Qualified Remodeling Contractor Repair/Correct as needed.

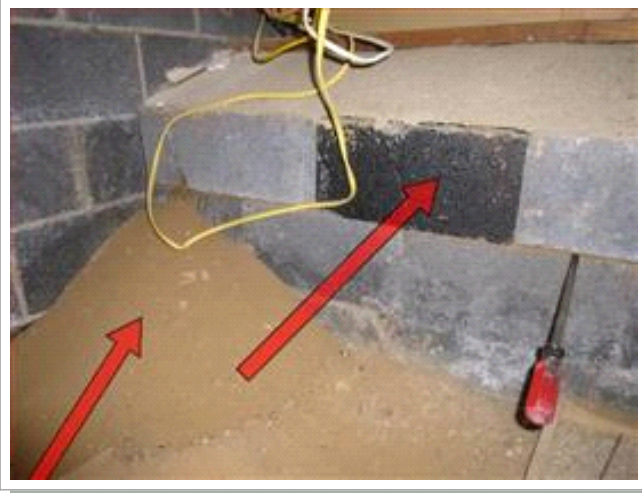
Figure Number 5

The block foundation wall in the crawlspace, which appears to hold back the garage floor, is comprised of loose blocks without mortar. Signs of dirt movement noted. Recommend: Qualified Mason Contractor Evaluate/Repair/Correct.

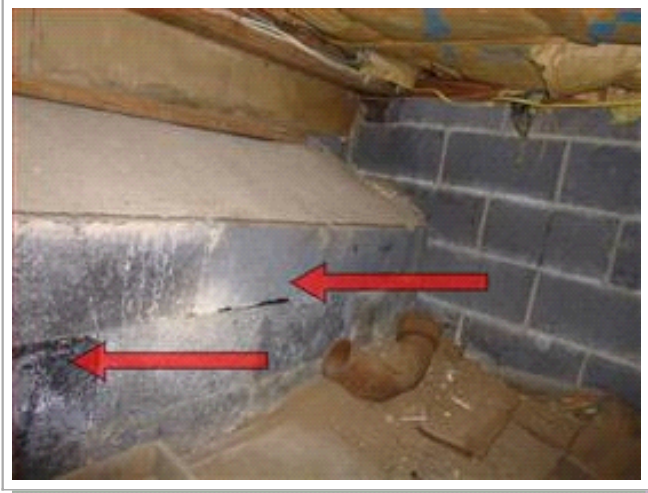
Figure Number 6

The block foundation wall in the crawlspace, which appears to hold back the garage floor, is comprised of loose blocks without mortar. Signs of dirt movement noted. Recommend: Qualified Mason Contractor Evaluate/Repair/Correct.

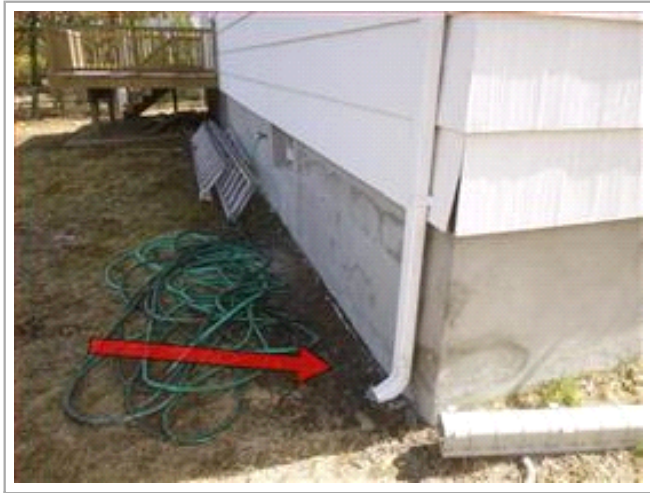
Figure Number 8

Low areas noted on exterior near foundation should slope away for proper drainage. Gutters terminate too close to the home. Recommend: Repair as Needed.

Surface Water Control	<input type="checkbox"/> Satisfactory <input checked="" type="checkbox"/> Upgrade Recommended
Fencing	<input type="checkbox"/> Wood <input type="checkbox"/> Metal <input type="checkbox"/> Satisfactory <input type="checkbox"/> Repairs Recommended <input checked="" type="checkbox"/> N/A
Remarks	<ul style="list-style-type: none"> <li>I Low areas noted on exterior near foundation should slope away for proper drainage. Gutters terminate too close to the home. Recommend: Repair as Needed. (See Figure #7) (See Figure #8)</li> <li>I See Summary Remarks</li> </ul>

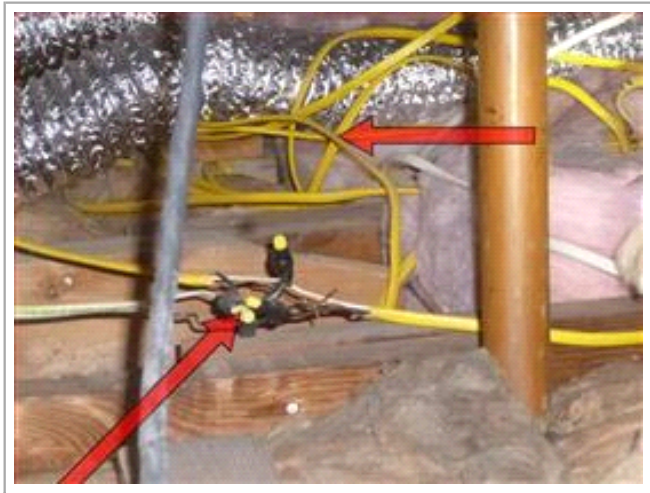
Figure Number 10

Most of the kitchen GFI outlets are mis-wired and not working properly. Reversed polarity outlets found in master bedroom and "open grounded" outlets found in several rooms. Live wires noted at missing fixtures. Wire nut connections and loose wires in attic. Recommend: Qualified Electrical Contractor Evaluate Entire system/Repair/Replace/Correct.

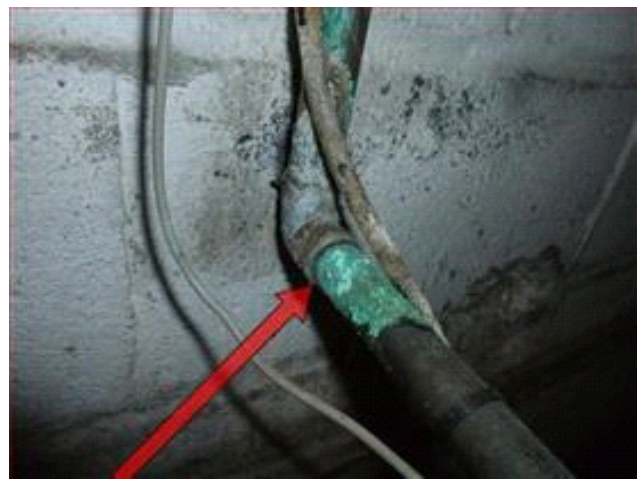
Figure Number 11

Active water leak noted at water meter fitting. Recommend: Qualified Plumbing Contractor Repair/Correct.

Remarks	<ul style="list-style-type: none"> <li>I Active water leak noted at water meter fitting. Recommend: Qualified Plumbing Contractor Repair/Correct. (See Figure #11) (See Figure #12)</li> <li>I Water leak evidence noted in basement from bathroom piping above. Recommend: Qualified Plumbing Contractor Evaluate/Repair/Correct. (See Figure #13) (See Figure #14) (See Figure #15)</li> <li>I See Summary Remarks</li> </ul>

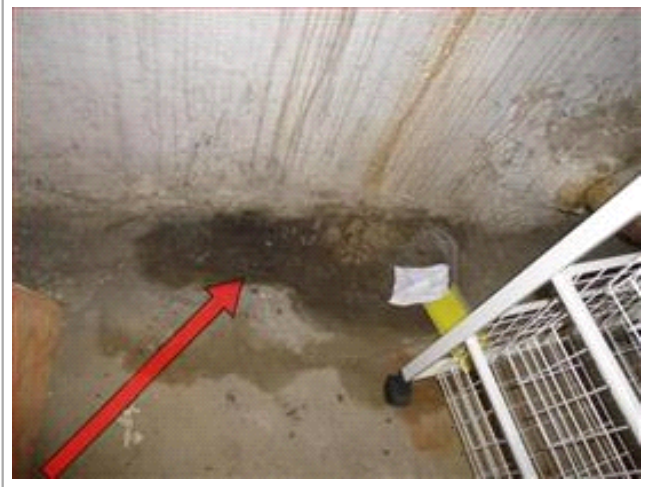
Figure Number 12

Active water leak noted at water meter fitting. Recommend: Qualified Plumbing Contractor Repair/Correct.

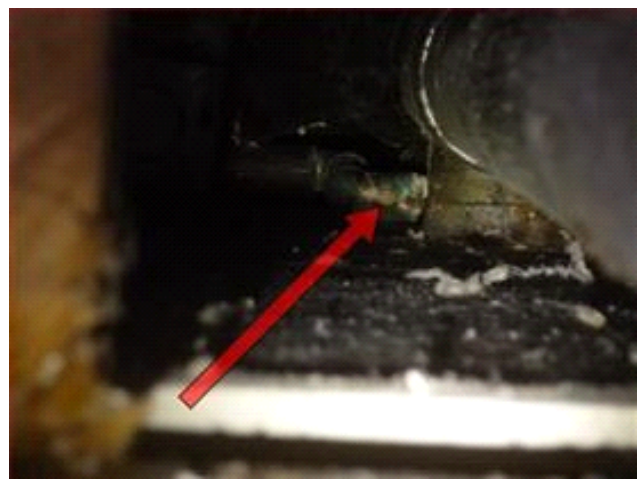
Figure Number 13

Water leak evidence noted in basement from bathroom piping above. Recommend: Qualified Plumbing Contractor Evaluate/Repair/Correct.

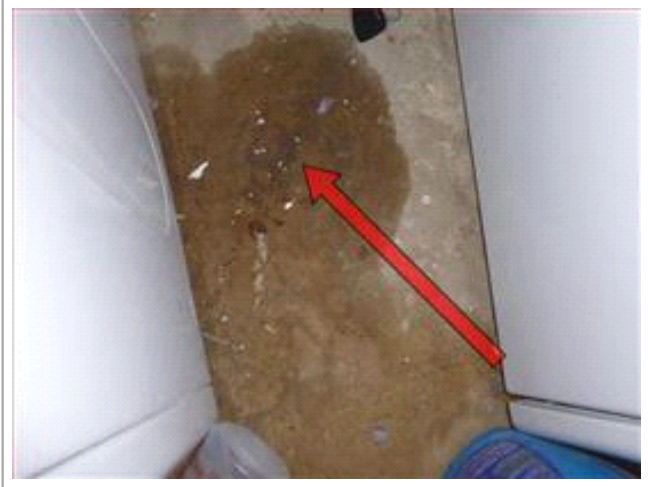
Figure Number 14

Water leak evidence noted in basement from bathroom piping above. Recommend: Qualified Plumbing Contractor Evaluate/Repair/Correct.

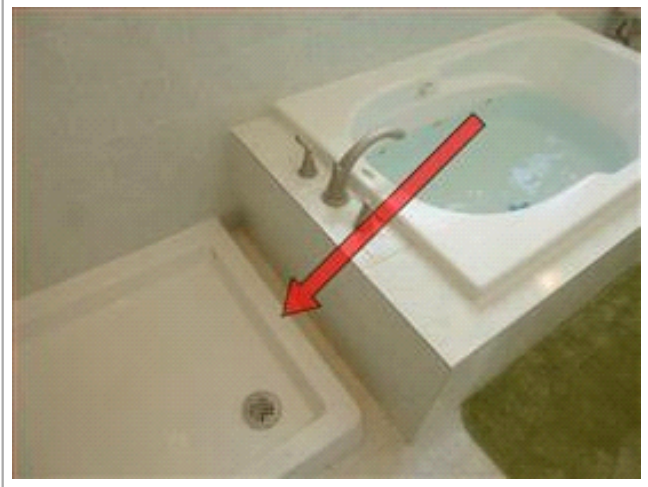
Figure Number 16

The master bathroom shower is missing it's surround. Not able to fully test water flow and hot water due to lack of containment of water. Recommend: Qualified Remodeling Contractor Complete/Repair/Test/Correct.

Caulking at fixtures	<input type="checkbox"/> Satisfactory <input checked="" type="checkbox"/> Loose <input type="checkbox"/> Mildewed <input type="checkbox"/> Missing <input checked="" type="checkbox"/> Repairs Recommended
Ventilation	<input checked="" type="checkbox"/> Window (s) <input type="checkbox"/> Fan to exterior <input type="checkbox"/> Fan to attic only <input type="checkbox"/> None <input checked="" type="checkbox"/> Repairs Recommended <input checked="" type="checkbox"/> Fan to unknown
Remarks	<ul style="list-style-type: none"> <li>I Window in master bathroom at jet tub does not appear to be a "tempered" glass type. Recommend: Qualified Remodelling Contractor Evaluate/Repair if Needed.</li> <li>I The master bathroom shower is missing it's surround. Not able to fully test water flow and hot water due to lack of containment of water. Recommend: Qualified Remodeling Contractor Complete/Repair/Test/Correct. (See Figure #16)</li> <li>I See Summary Remarks</li> </ul>

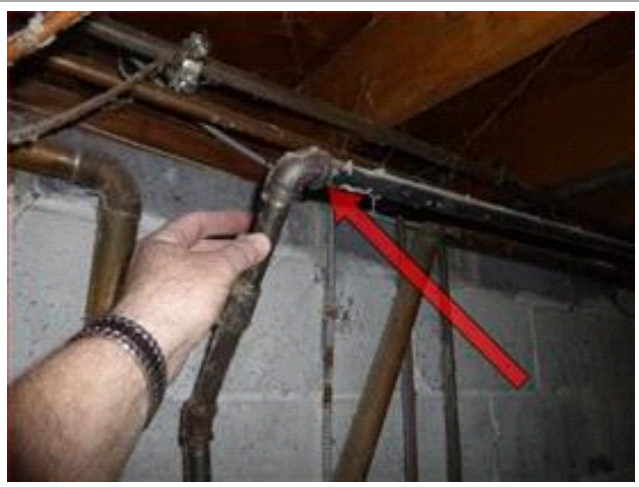
Figure Number 17

No shut off valve noted for dryer. The gas line in basement at rear wall is loose and needs to be secured. Recommend: Qualified Plumbing Contractor Repair/Correct.

Kitchen / Appliances	No shut off valve noted for dryer. The gas line in basement at rear wall is loose and needs to be secured. Recommend: Qualified Plumbing Contractor Repair/Correct. (See Figure #17)
Kitchen / Appliances	No kitchen cabinets or counter-tops. Temporary sink and loose stove only. Damaged flooring noted. Kitchen is being remodeled. Recommend: Checking with township to verify that permits and inspections are in order.
Interior / Finished Areas	The master bedroom does not have a closet. Both smaller bedrooms are missing closet doors. Recommend: Repair.
Interior / Finished Areas	Loose and improper railing noted at beginning of main staircase. Need complete railing installed on main staircase. Should install proper baluster system on basement staircase. Recommend: Repair for safety.
Interior / Finished Areas	Water stains were noted in the master bedroom at front ceiling, under the upstairs hall skylight, in hall closet on main level, and under the master bathroom skylight. Ceiling cracks noted in the dining room under the master bathroom. Recommend: Qualified Remodeling Contractor Evaluate/Repair/Correct.

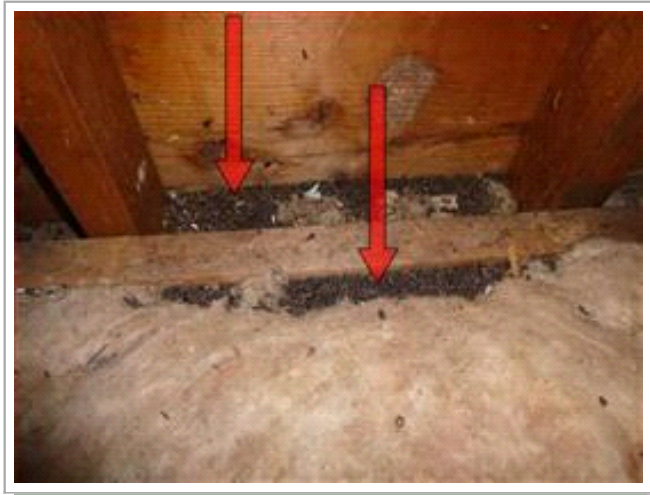
Figure Number 20

The brick chimney has areas of cracks and damaged mortar. Daylight noted in attic with bat evidence at chimney. Recommend: Qualified Mason Contractor Repair/Correct & Qualified Pest Control Contractor Treat/Remove as Needed.

Carport	<input type="checkbox"/> Covered <input type="checkbox"/> Walls <input type="checkbox"/> Attached <input type="checkbox"/> Detached <input type="checkbox"/> Satisfactory <input checked="" type="checkbox"/> N/A <input type="checkbox"/> Repairs needed.
Electrical Outlets	<input checked="" type="checkbox"/> Should be GFI protected <input checked="" type="checkbox"/> Repairs Recommended
Hose Bibs	<input type="checkbox"/> N/A <input checked="" type="checkbox"/> Water off, no test <input type="checkbox"/> Satisfactory <input checked="" type="checkbox"/> Repairs Needed
Remarks	<ul style="list-style-type: none"> <li>I The brick chimney has areas of cracks and damaged mortar. Daylight noted in attic with bat evidence at chimney. Recommend: Qualified Mason Contractor Repair/Correct &amp; Qualified Pest Control Contractor Treat/Remove as Needed. (See Figure #19) (See Figure #20) (See Figure #21)</li> <li>I See Summary Remarks</li> </ul>

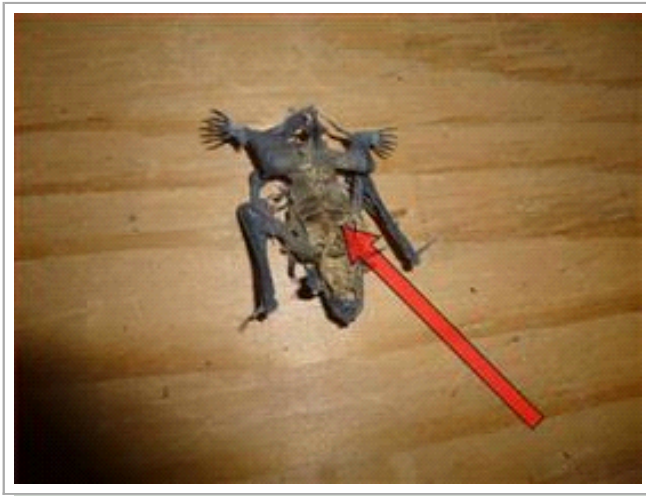
Figure Number 21

The brick chimney has areas of cracks and damaged mortar. Daylight noted in attic with bat evidence at chimney. Recommend: Qualified Mason Contractor Repair/Correct & Qualified Pest Control Contractor Treat/Remove as Needed.
